Dam Inspection Report

Name of Dam Wonder Lake Dam ID No. IL00585
Permit Number NE2003078 Class of Dam Class I
Location SE Section 6 Township 45N Range 8E

Type of Dam: Earth-Fill Embankment with Ambursen Spillway

Date(s) Inspected 10/18/2024

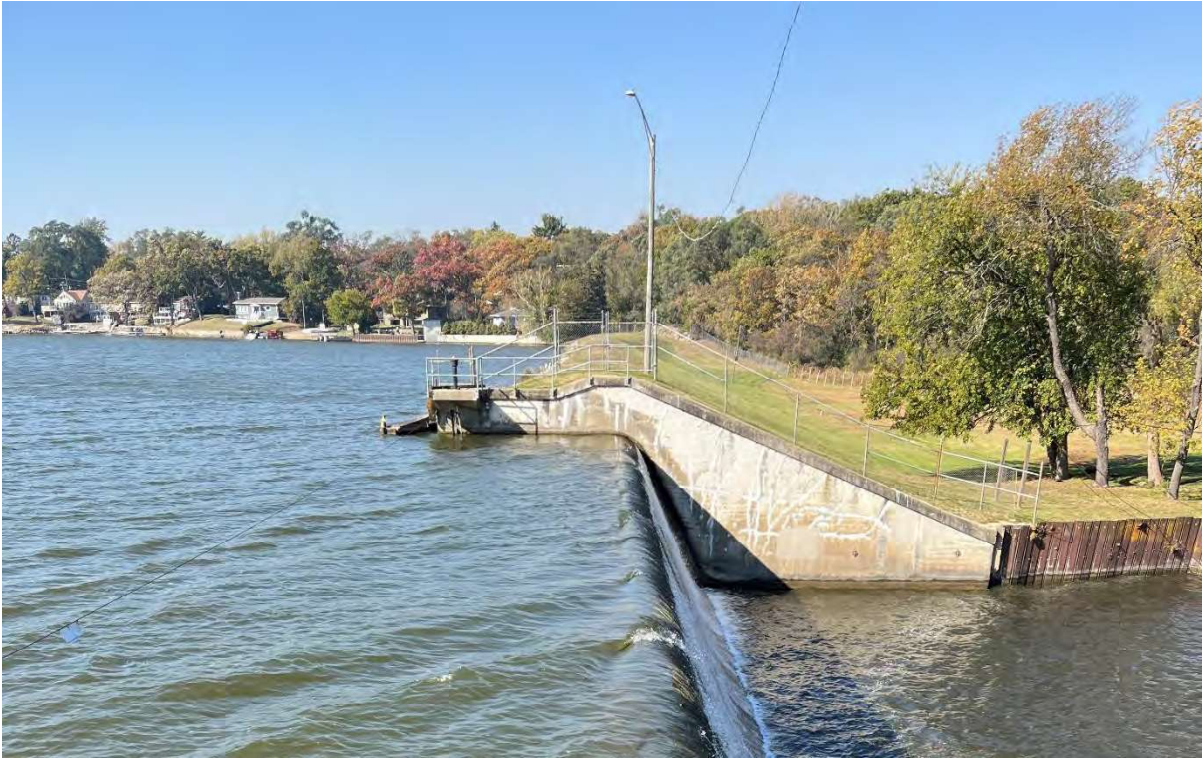
Photo 1: Spillway Crest (Facing west)

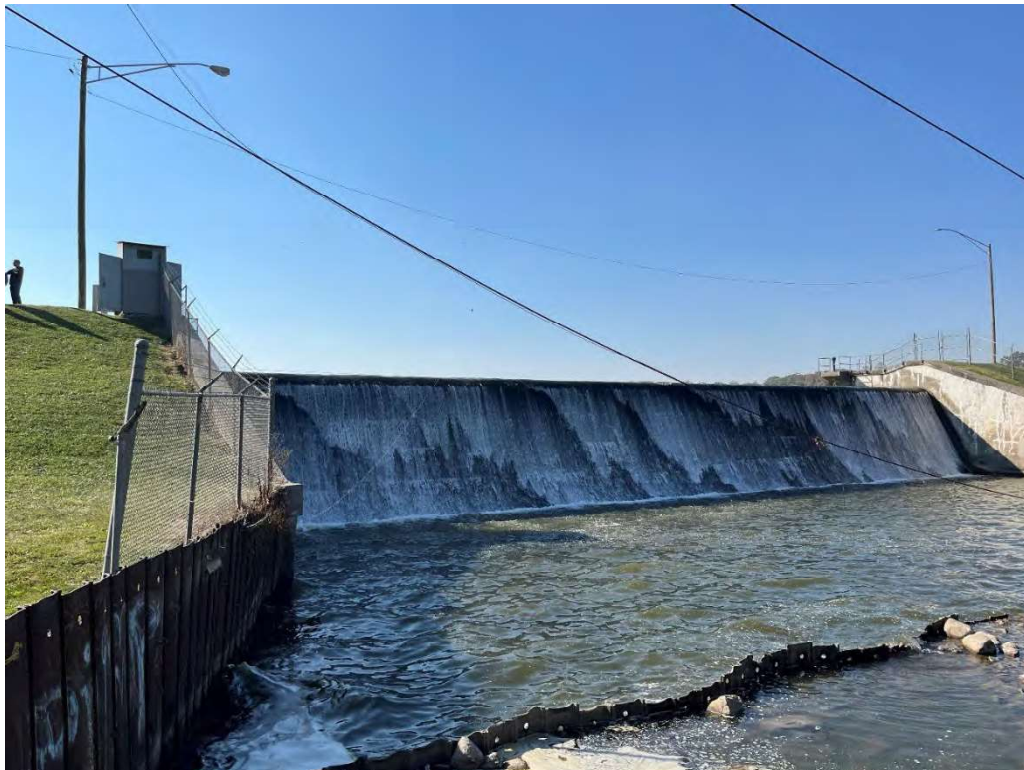
Photo 2: Downstream Face of Spillway

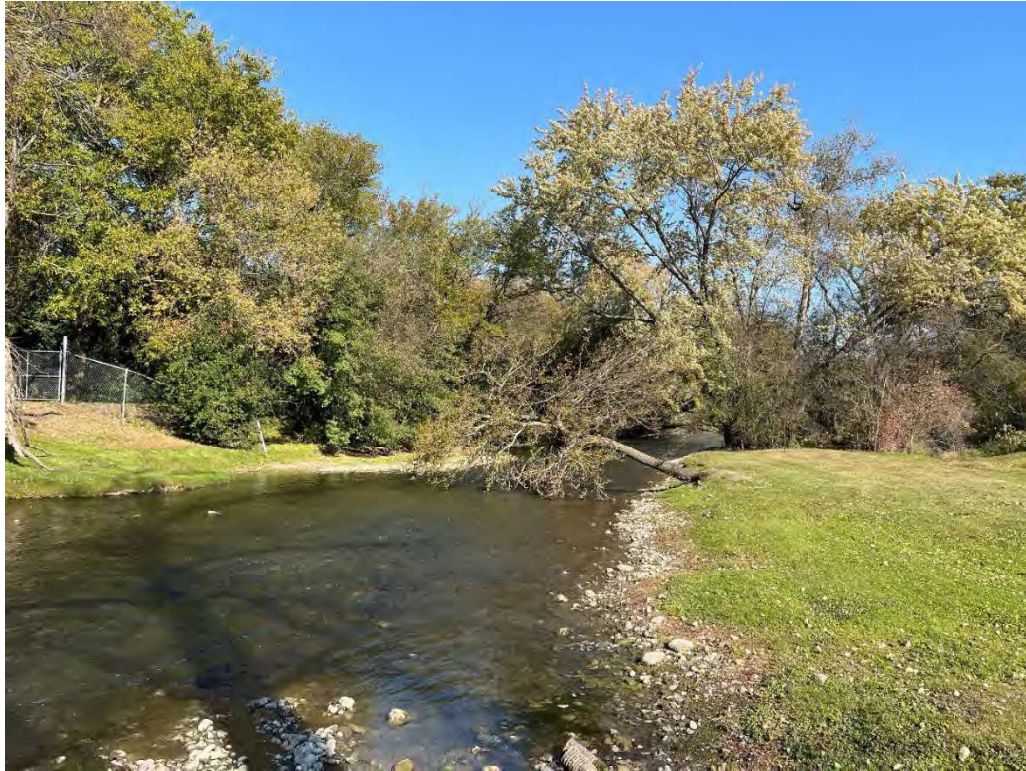
ITEM	CONDITION CODE	DEFICIENCIES	RECOMMENDED REMEDIAL MEASURES AND IMPLEMENTATION SCHEDULE
Riprap	GC		
Outlet Channel	GC	Minor erosion but overall good condition and stable. No threat to dam.	
Debris	NE		
Other (Name)	NA		
Other	NA		
Other			
Other

Photo 3: Downstream Channel

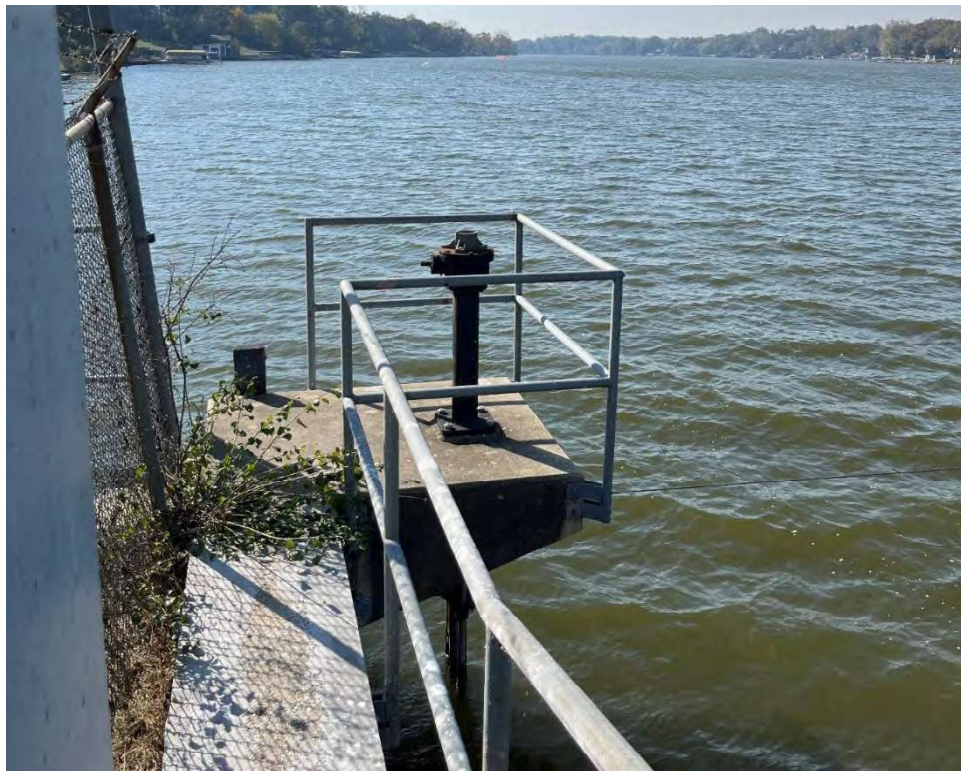
ITEM	CONDITION CODE	DEFICIENCIES	RECOMMENDED REMEDIAL MEASURES AND IMPLEMENTATION SCHEDULE
Gate Sill	GC/MM	East Gate was opened and closed during the dam inspection. There are no issues with the gate components. West Gate inoperable.	Repair West Gate.
Gate Seals	GC/MM	East Gate was opened and closed during the dam inspection. There are no issues with the gate components. West Gate inoperable.	Repair West Gate.
Gate and Frame	GC/MM	East Gate was opened and closed during the dam inspection. There are no issues with the gate components. West Gate inoperable.	Repair West Gate. Note that west gate shaft and steel protection framing are bent.
Operating Machinery	NI		
Emergency Operating Machinery	NA		
Other (Name)			
Other

Photo 8: East Sluice Gate Control

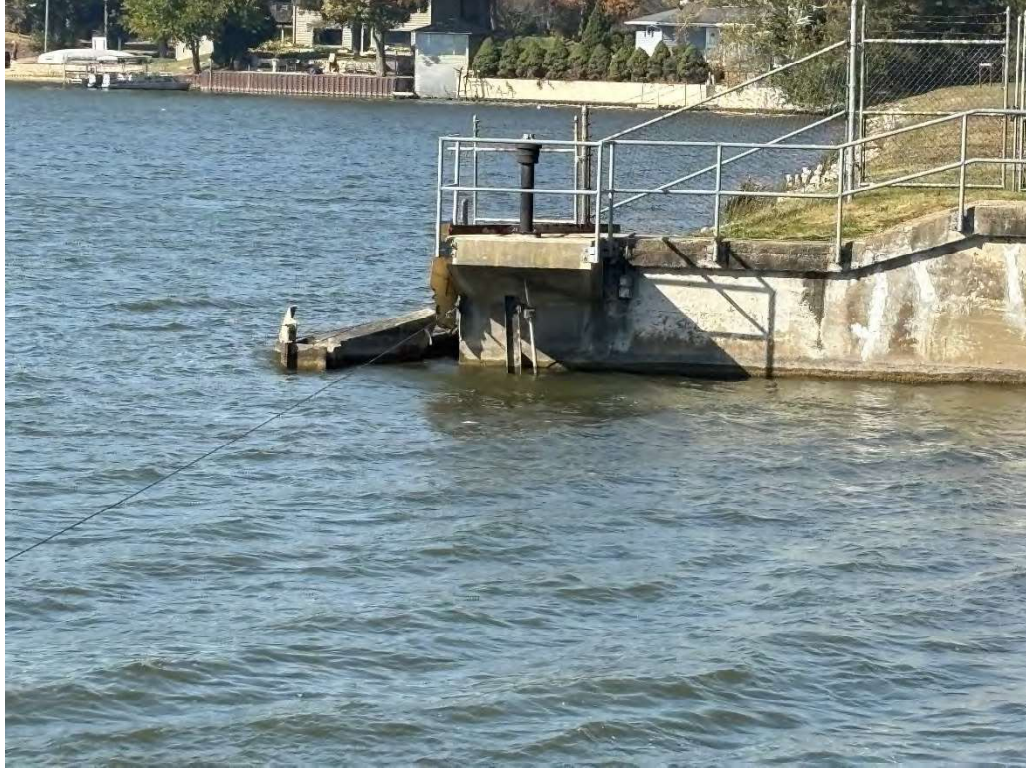
Photo 9: West Sluice Gate – Shaft and steel protection framing is bent – Gate is inoperable

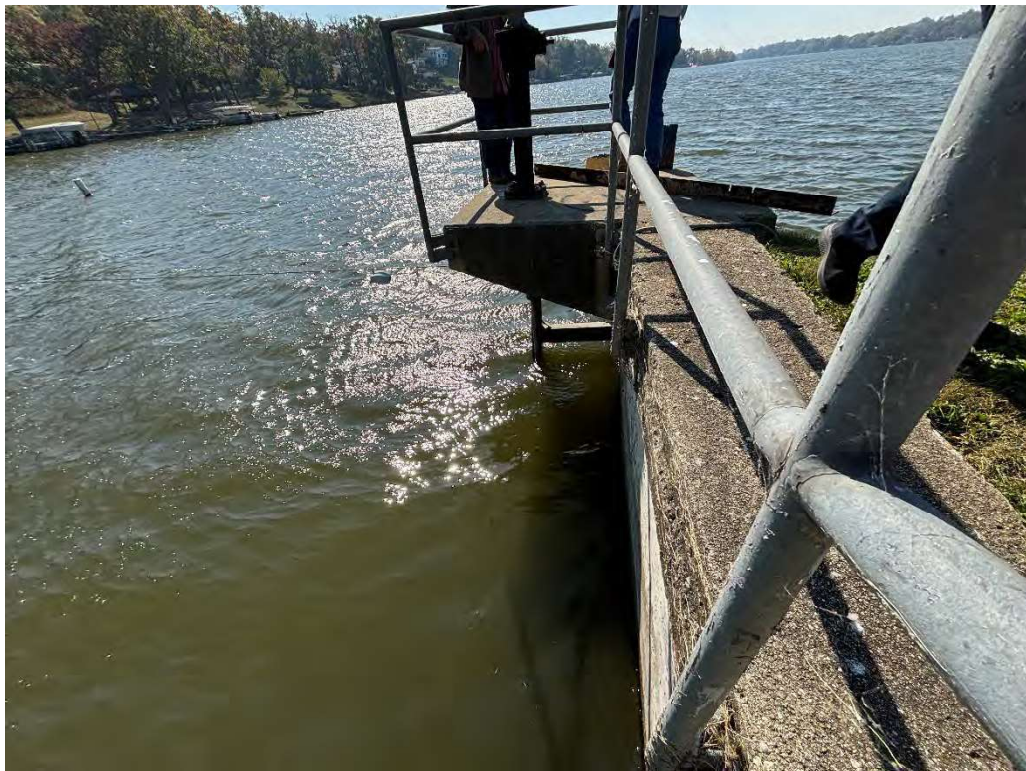
Photo 10: Downstream Side of West Sluice Gate

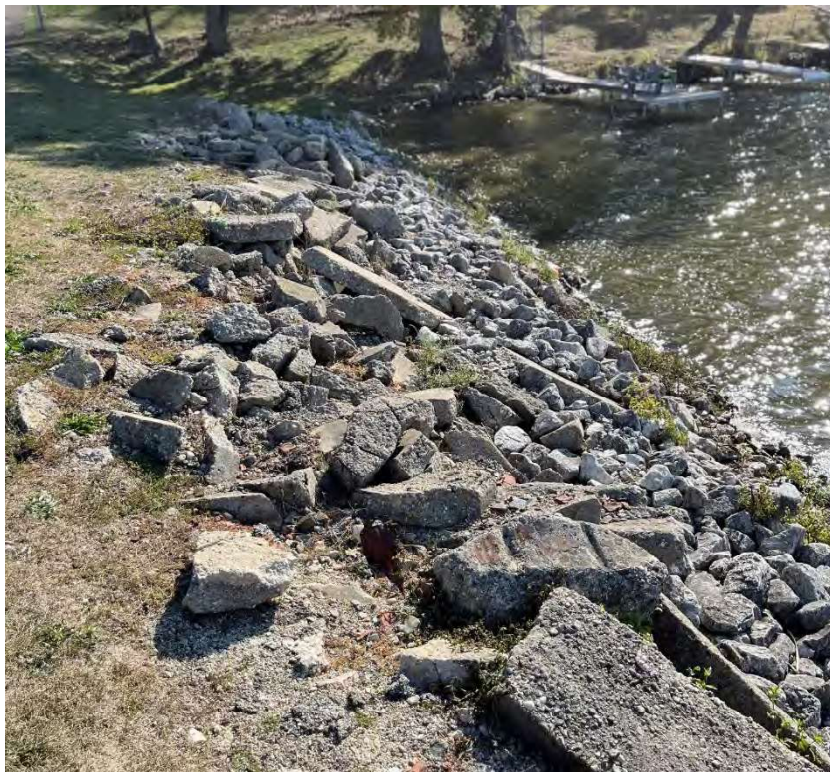
Photo 12: East Embankment – Upstream Face Riprap (Facing East)

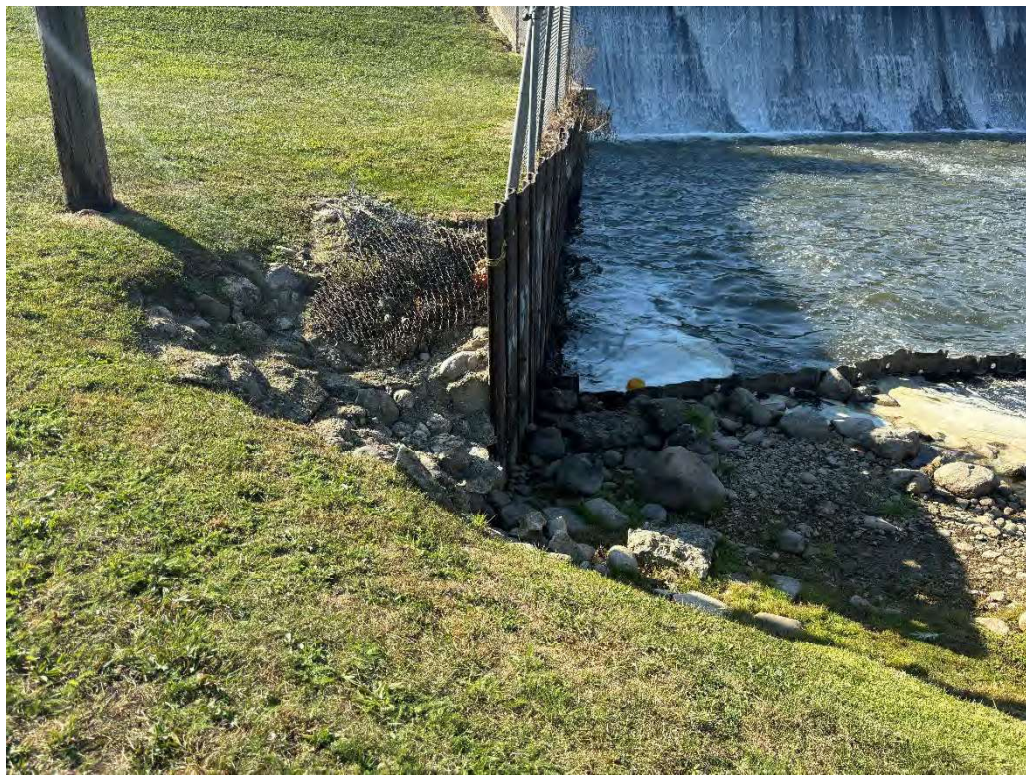
Photo 16 – Erosion at Downstream End of East Abutment - Monitor

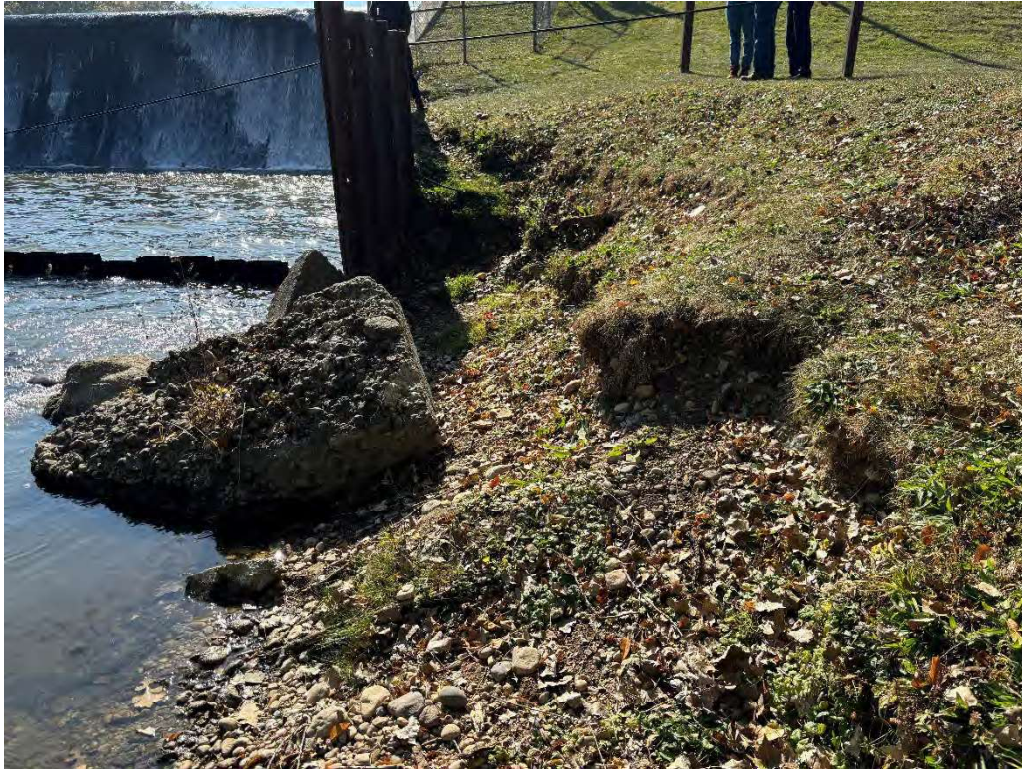
Photo 17 - Erosion at Downstream End of East Abutment - Monitor

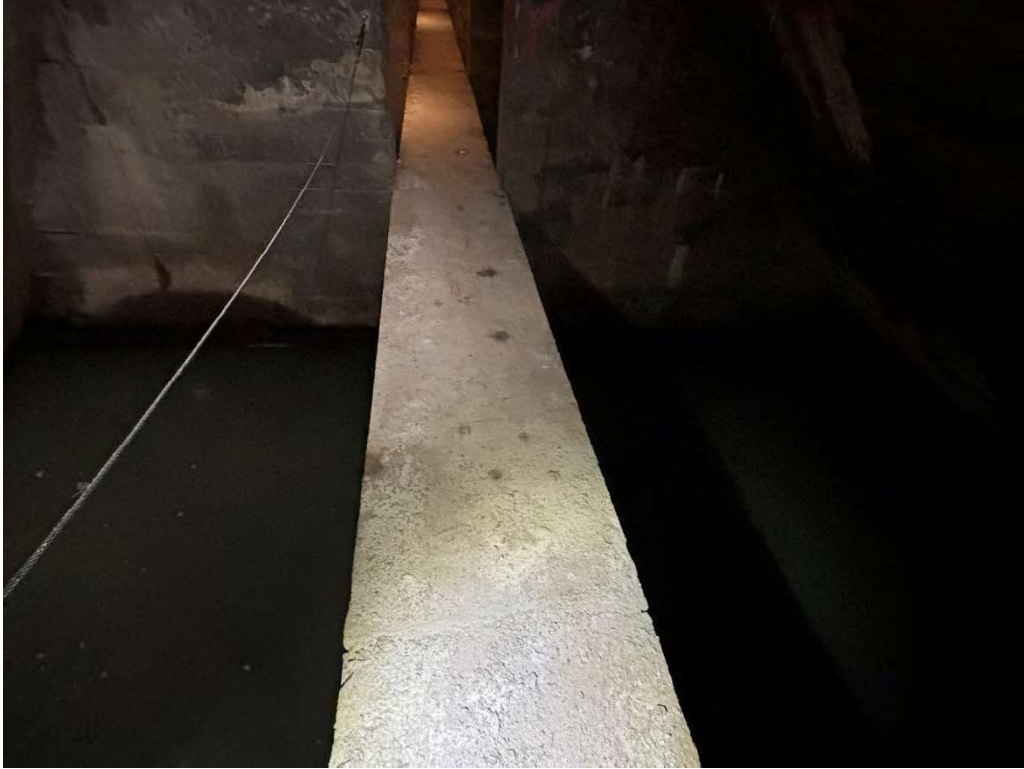
Photo 57: Typical Walkway Condition
